Matteo Scarponi, Wolfson Unit MTIA, University of Southampton, M.Scarponi@soton.ac.uk

This paper describes the use of the Wolfson guidance and other stability criteria in the context of two recent accident investigations on small fishing vessels: 11.4m scallop dredger JMT and 9.9m stern trawler Stella Maris. Both vessels capsized and sank whilst handling their catch in benign weather conditions. The Wolfson guidance, which is suitable for all types of fishing vessels including those with no stability information, enables estimation of the safe operational limits for both JMT and Stella Maris. Also, given the probable loss scenarios and residual stability characteristics, the Wolfson guidance predicted that both vessels were operating outside such limits at the time of each loss.

3. FV JMT INVESTIGATION

4. FV STELLA MARIS INVESTIGATION

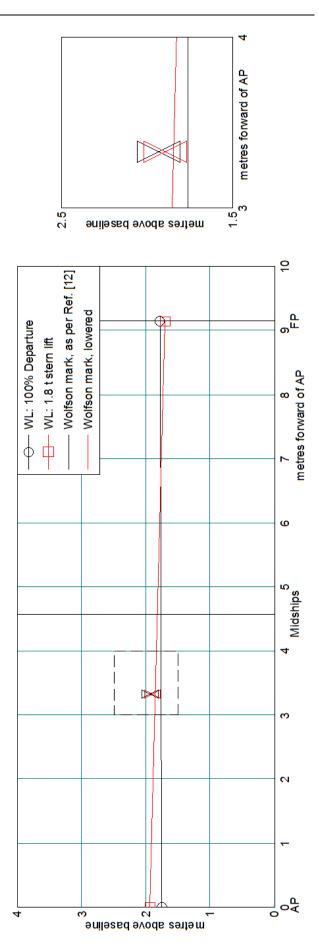
Figure 8 – 100% departure and 1.8t stern lift waterlines

However, Figure 7 indicates that perhaps the mark should have been lowered by about 40mm to achieve the calculated 250mm separation between the deck at side and the top edge of the mark. Such a vertical shift would position the lower edge of the Wolfson mark at the port departure waterline, as

shown in Figure 8. So the vessel in the port departure condition appears to be at the boundary of the green and amber safety zones.

Figure 8 shows two waterlines derived from the vessel's calculated draughts at FP and AP, as indicated in Annex B of Ref. [13]. The Wolfson mark is positioned as per MAIB report, but its correct position may be further aft and approximately 40mm lower than in the report, as discussed in Sections 4.3 and 4.4 above.

The red waterline of Figure 8 represents the 1.8t stern lift, zero heel condition described in Annex B, page 64. As the Wolfson mark is partially immersed, the Wolfson guidance indicates a 'low level of safety' for the vessel in that load condition.

The gilson winch is rated at 2.8t (first layer pull) so hoisting 1.8t should be regarded as a realistic operating condition that reduces the vessel's freeboard to a level that, according to the Wolfson guidance, may endanger the vessel.

For the probable loss condition described in Annex B, page 69 the calculated equilibrium heel angle is 8.4 degrees to starboard. A simple calculation shows that a Wolfson mark affixed on the starboard side of the vessel would be submerged at that heel angle. Therefore, the Wolfson guidance predicts that the vessel's residual stability is reduced to an unsafe level in such a condition, and the vessel is in danger of capsize.

Calculations based on the data presented in Ref. [13] suggest that the position of the freeboard mark applied to the sister vessel of FV Stella Maris was incorrect. In particular, the appropriate position of the mark appears to be approximately 40mm lower and further aft (at the minimum freeboard location when undertaking a heavy lift) than indicated in the report, resulting in a more onerous freeboard requirement for the vessel.
